FITTING INSTRUCTIONS

MECHANICAL LEFT FOOT ACCELERATOR

PRODUCT CODE → NEW PASV

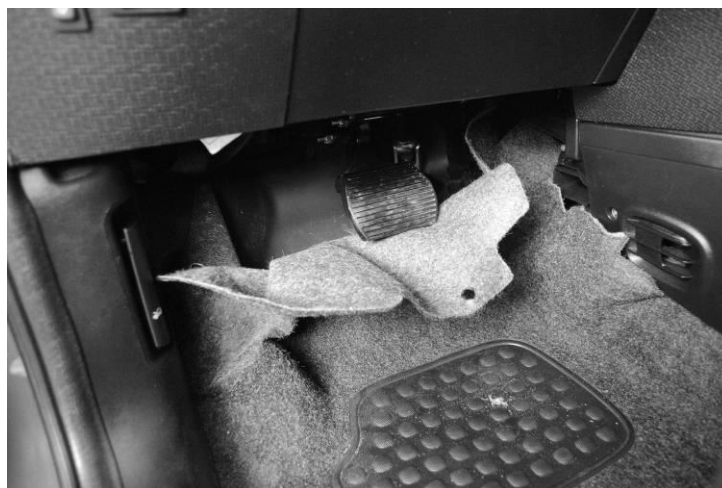
Picture 1

In the area near the pedals, lift the carpet and the padding and move them towards the driver's seat as shown in *Picture 1*; if necessary, remove the plastic parts that limit the possibility of lifting both the carpet and the padding.

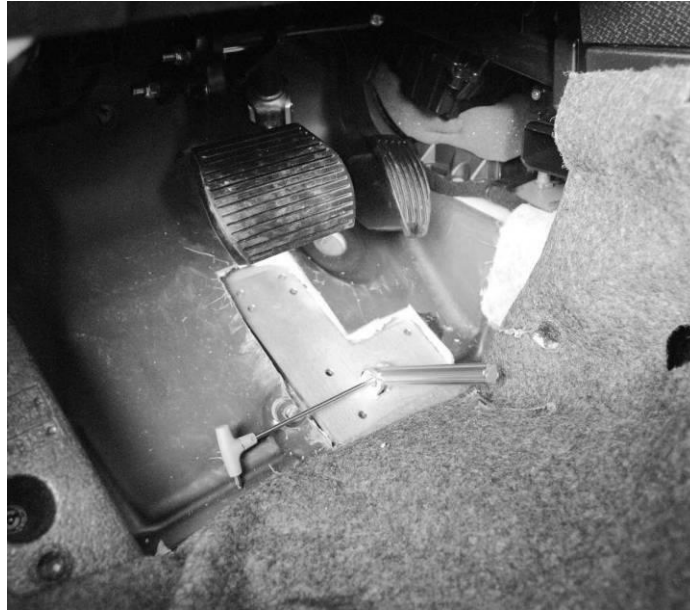
Picture 3

Before positioning, adjust the angle of the pin on the bracket to be fixed to the vehicle floor (*Picture 3*)

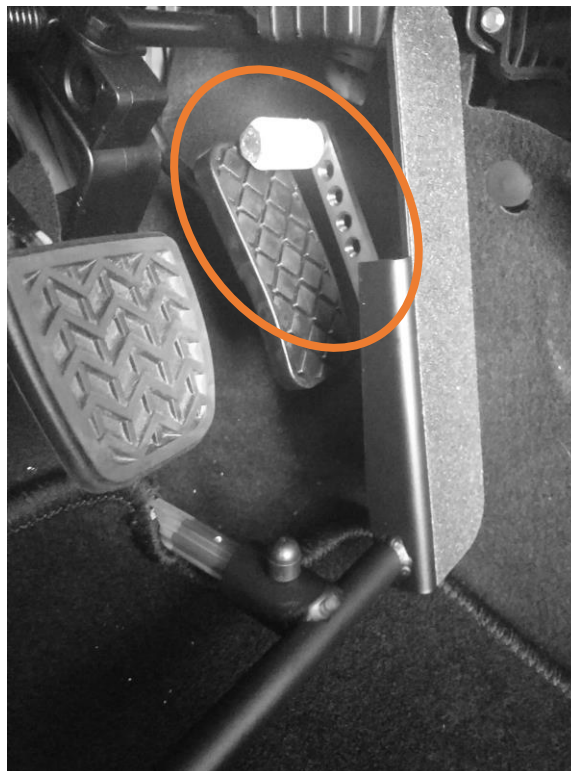
Picture 4

The plastic roller can also be placed in different positions (*Picture 4*) to adapt the device to different vehicles and make the run of the device accelerator pedal longer or shorter.

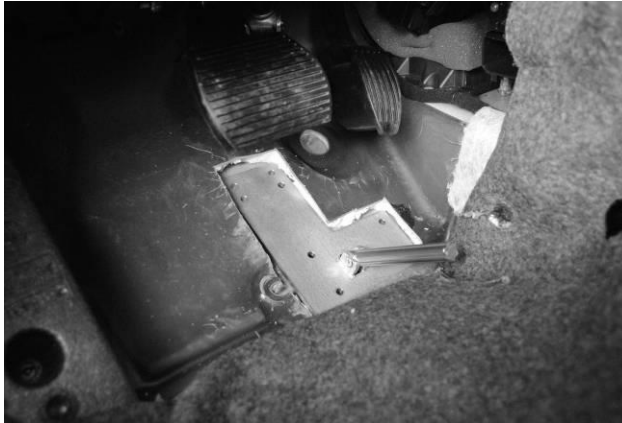
Picture 5

Remove the double pedal as shown in *Picture 5* and then shorten the pin using suitable tools, as shown in *Picture 6*.

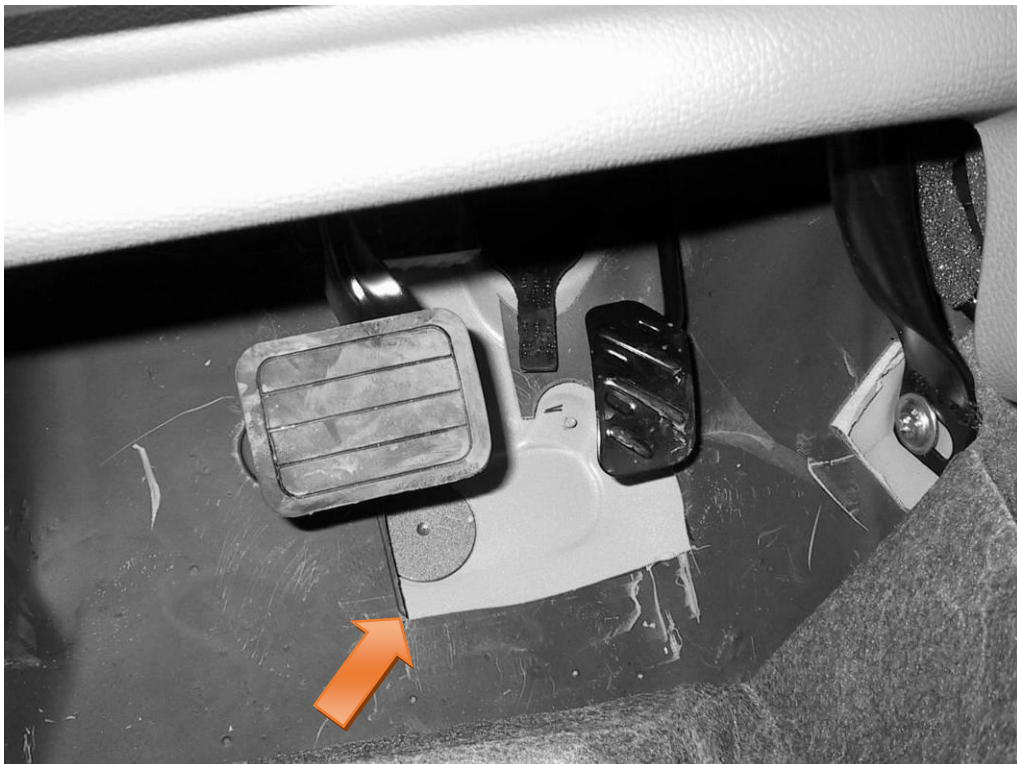
Picture 7

Cut the insulating padding on the vehicle floor, shaping it as shown in *Picture 7*, so that the pedal bracket can be placed directly on the sheet floor of the vehicle (the padding that was removed must be kept to be repositioned later).

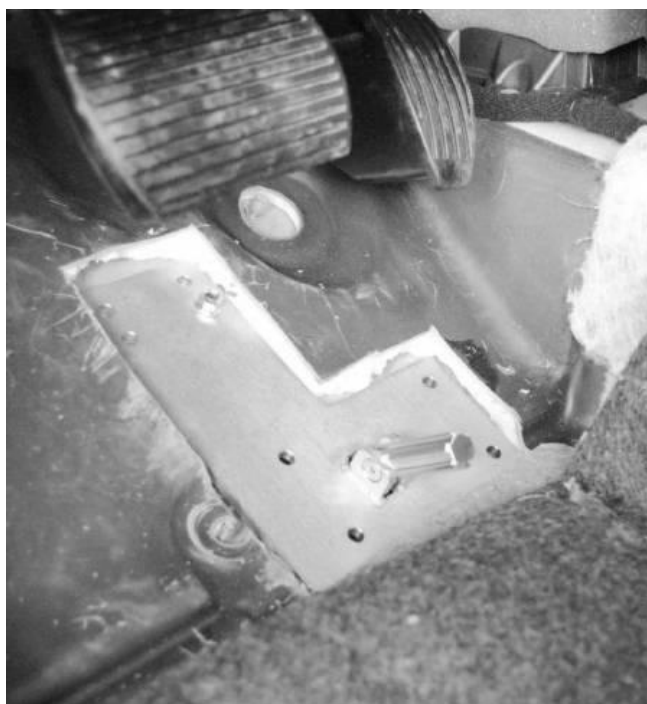
Picture 9

After having made this hole, fix the bracket temporarily and make sure it is in the correct position (*Picture 9*). If this condition has been satisfied, fix it in another 2 points, considering the same warnings indicated previously.

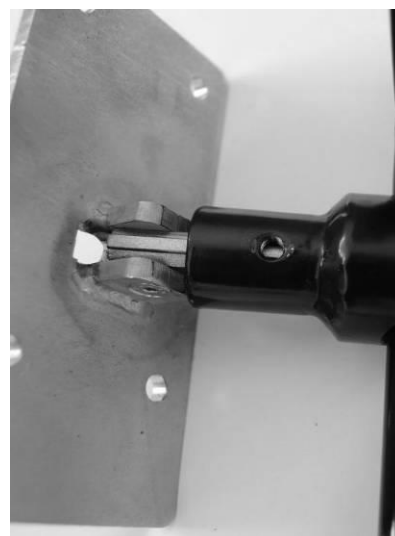
Picture 12

- Countersink the pin using a diam. 4 mm bit, as shown in *Picture 12*, then re-insert the M6 threaded plug so that the ball on the plug, when connecting the bushing to the pin, connects with the previously-made countersink. Tighten the M6 lock nut (*Picture 13*).

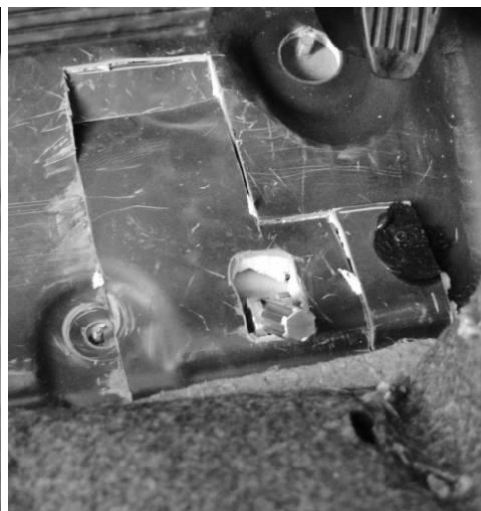
Picture 17

Shape the insulating padding cut previously and reposition it, allowing only the pin to exit, then fix it with glue or sealant (*Picture 17*); this operation makes it possible to soundproof the vehicle as it was originally and level the vehicle floor.

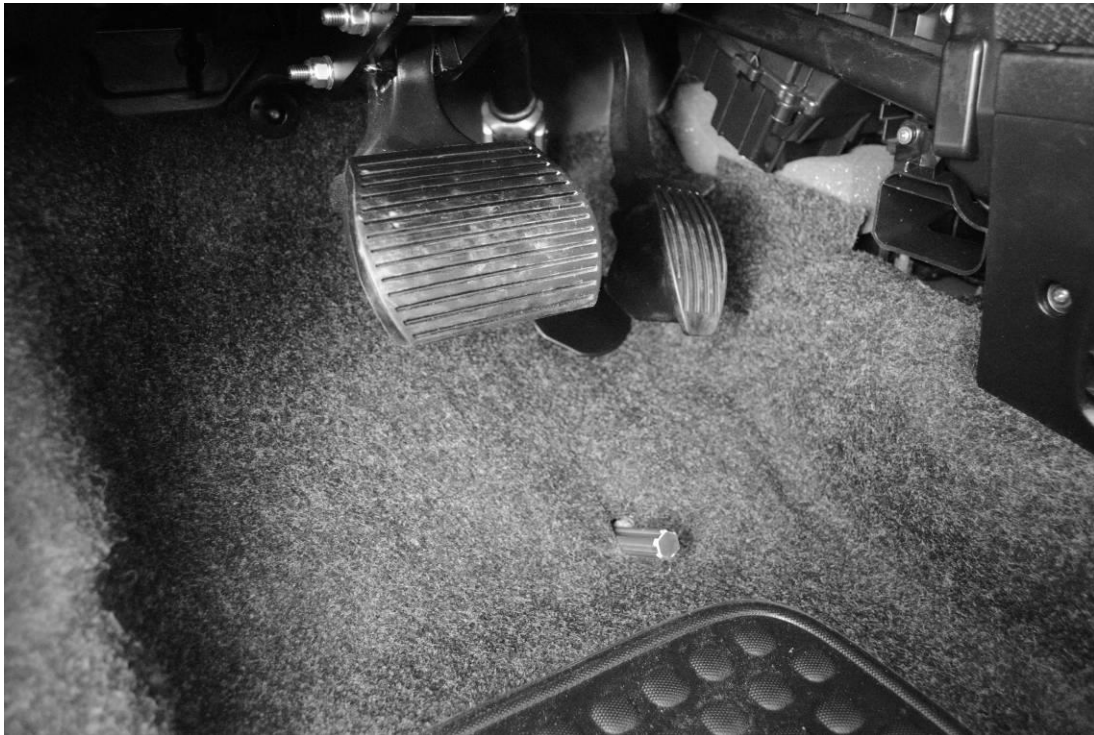
Picture 18

Now make a diam. 22 mm hole in the vehicle carpet to allow the pin to exit; this hole must be made very carefully to keep the vehicle aesthetics uncompromised.
Reposition the carpet definitively, return the plastic (if previously removed) to obtain a result as shown in *Picture 18*.

The result is satisfactory when the carpet is not raised near the pin, making the pin supporting bracket almost imperceptible.

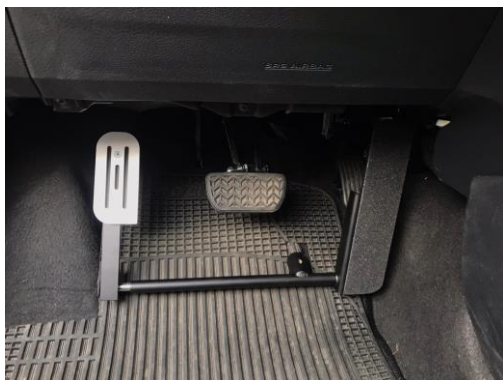
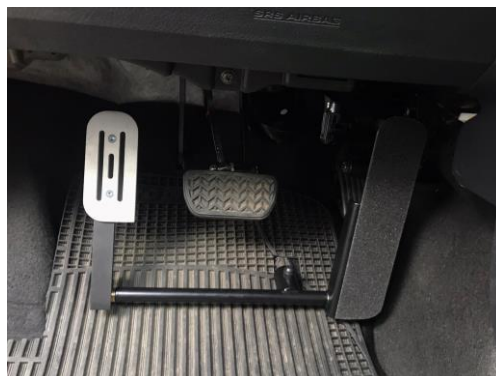
When inserting the double pedal onto the pin, in many cases the left-hand pedal is too distant from the brake pedal and collides with the wheel arch, as shown in *Picture 19*. As a consequence, the pedals must be adapted correctly, obtaining a result as shown in *Picture 20*, with the left pedal equidistant from the brake pedal and the wheel arch. In addition, we recommend keeping the left pedal at the same height as the brake pedal to make foot movement between the two pedals easier

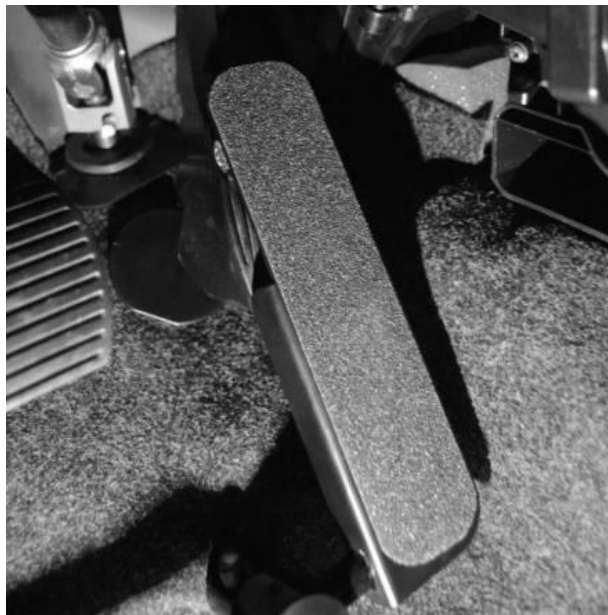
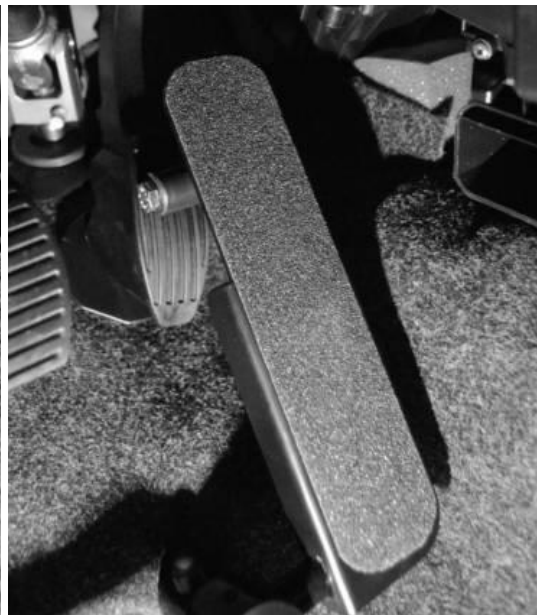
After having tested the vehicle both when stopped and moving, make sure the various parts are tightened correctly, that the transmission is positioned against the accelerator pedal correctly, both when in the rest position and when pressed (*Picture 24,25*) and that the double pedal has been inserted correctly on the pin.
